NRL Memorandum Report 4003

Shock Performance of a Shipboard Electrical Switchgear

EDWARD W. CLEMENTS

June 15, 1979

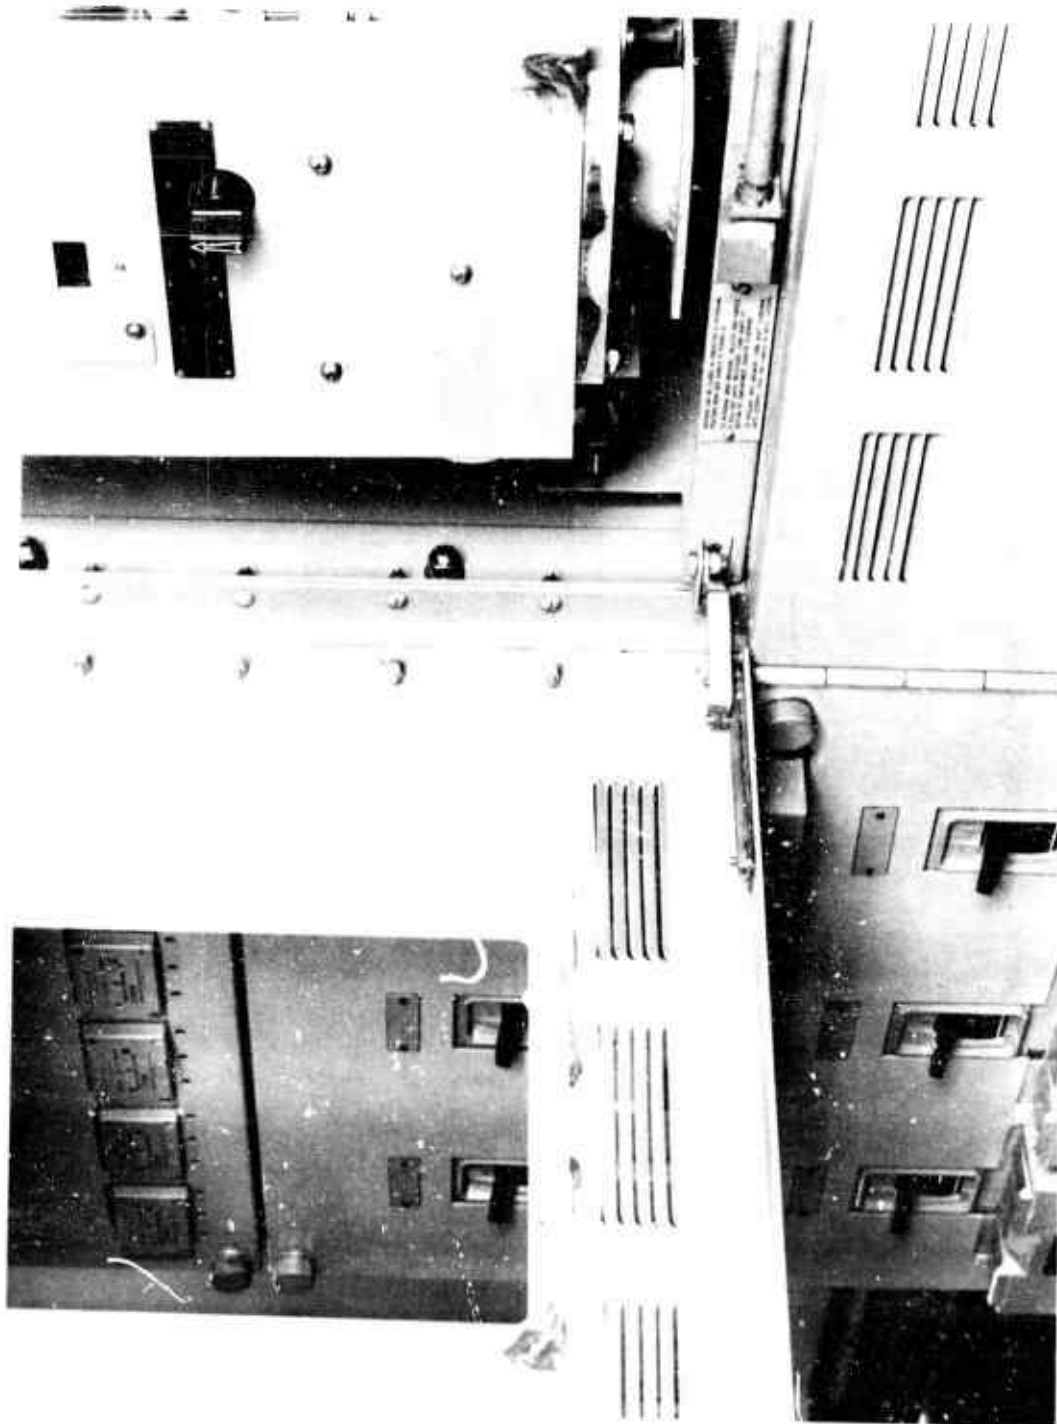
Damage was thus limited to the broken breaker ties referred to above, which were replaced with steel strips of similar dimensions, and wear and abrasion to the ACB breakers and their door panels, Figs. 16-18.

Fig. 16 - Damage from vibration test - upper ACR-1600. Note abrasion of breaker and door, and bending of louvers.

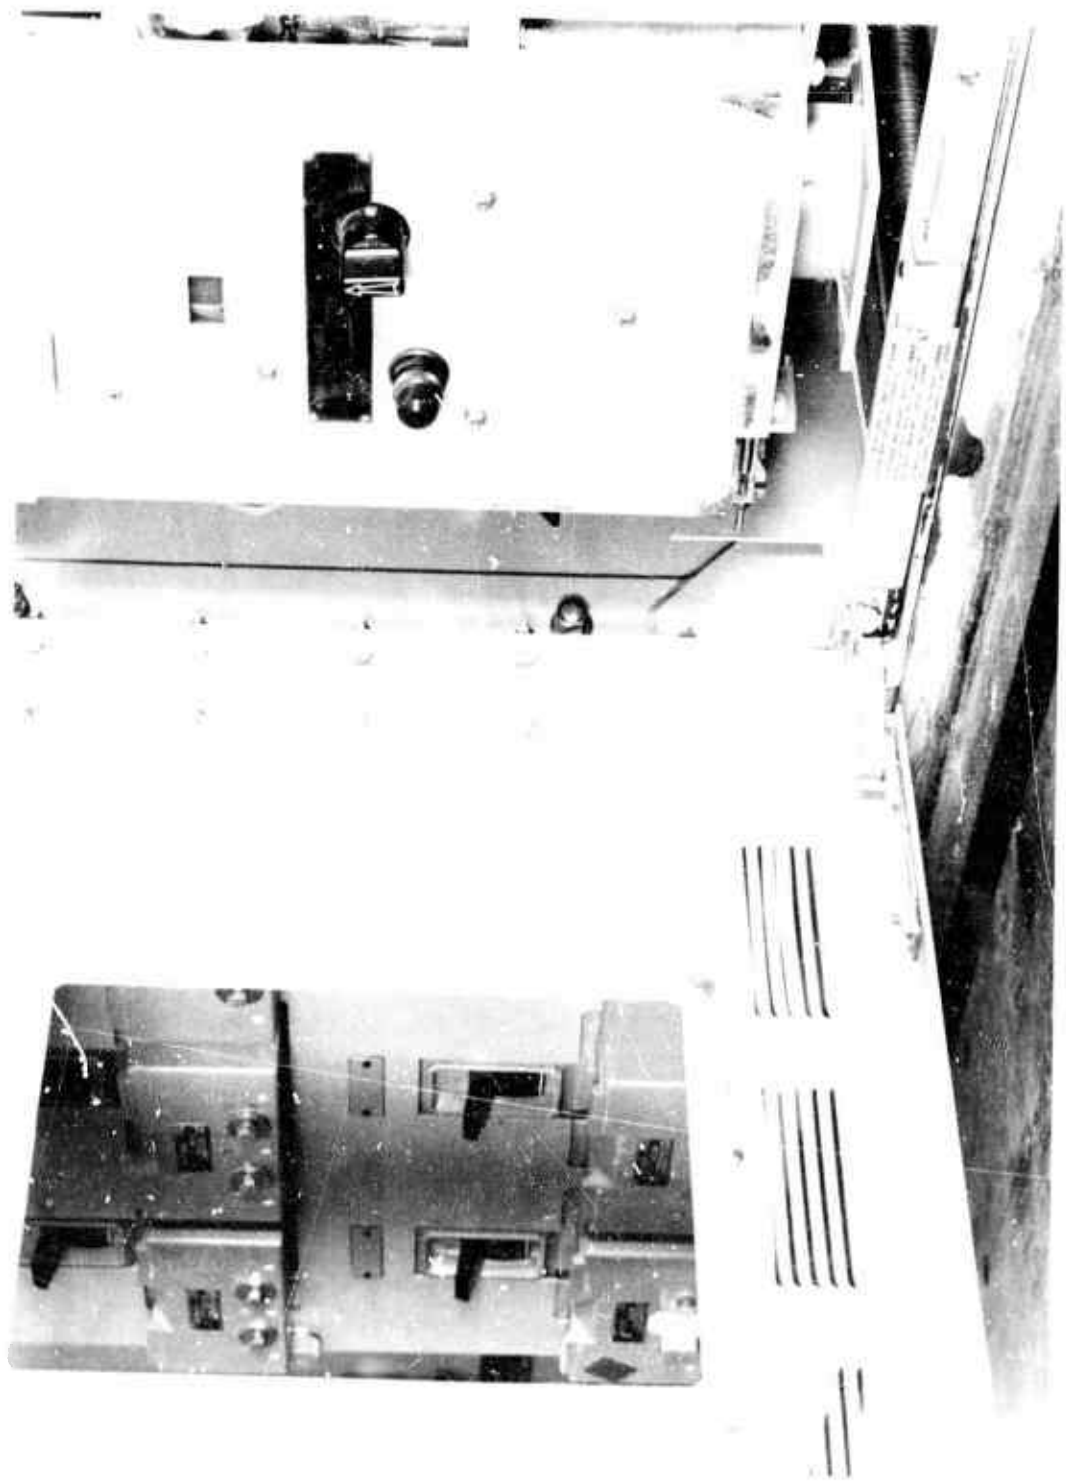
Fig. 17 - Damage from vibration test - lower ACB-1600. Note abrasion of breaker and door, and bending of louvers.

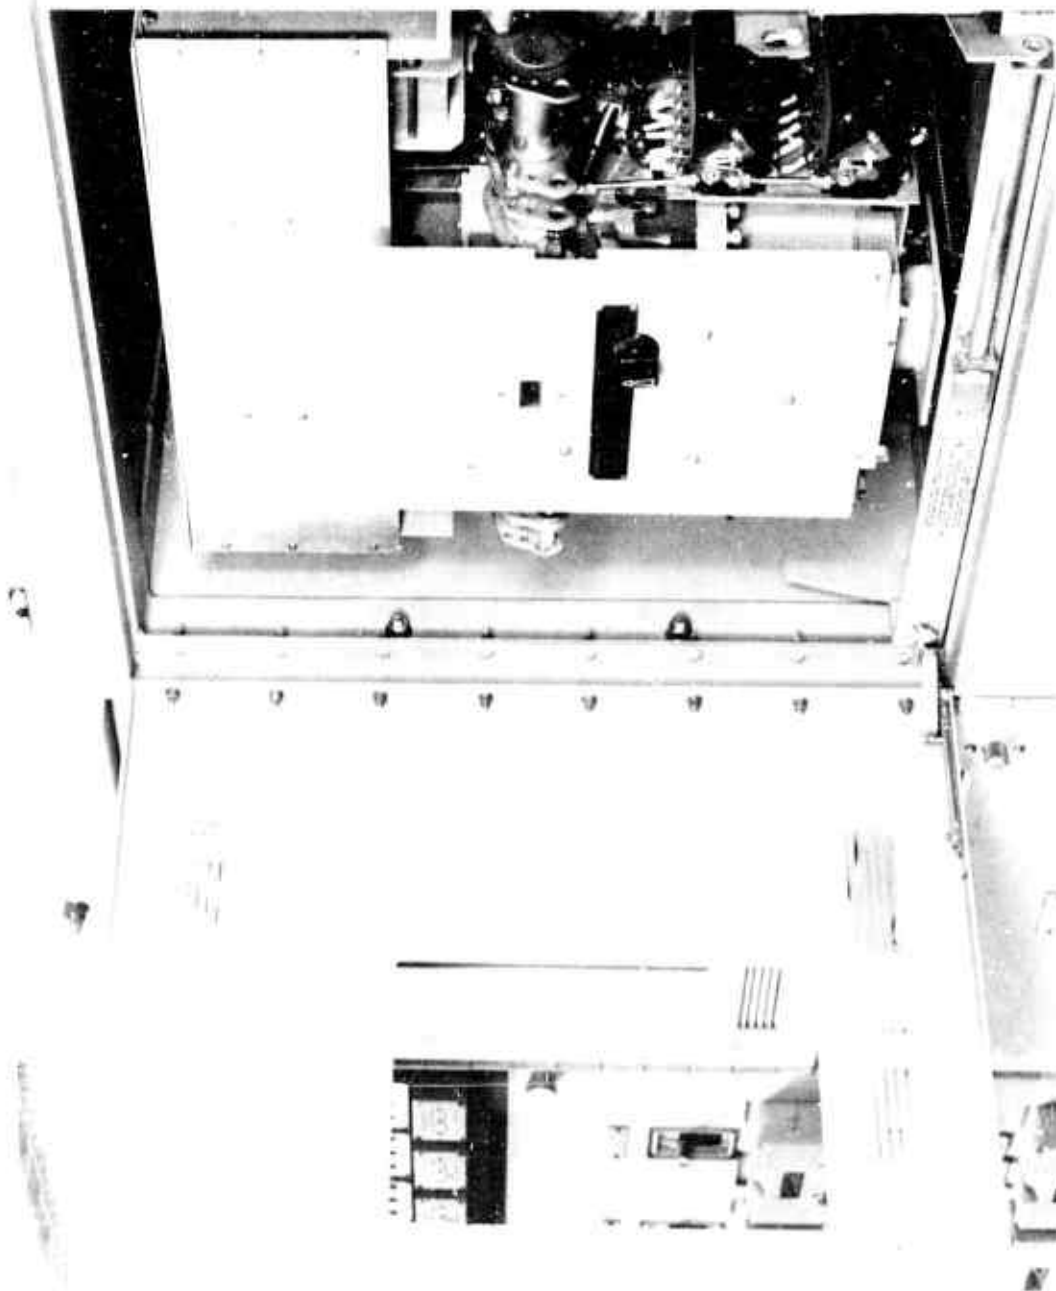
Fig. 18 - Damage from vibration test - ACB-2400. Note abrasion of breaker and door, and bending of louvers.

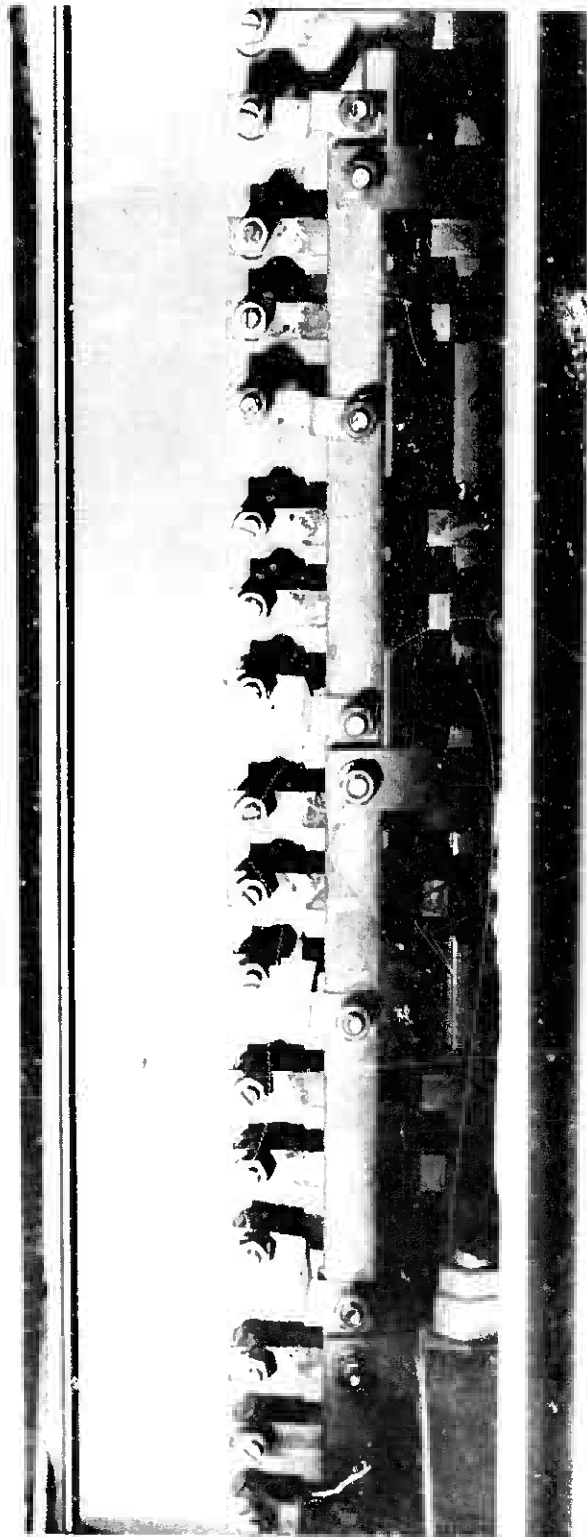
Fig. 19 - Damage from vibration test - upper horizontal bus (LF101). Note broken feeds from bus to breakers.

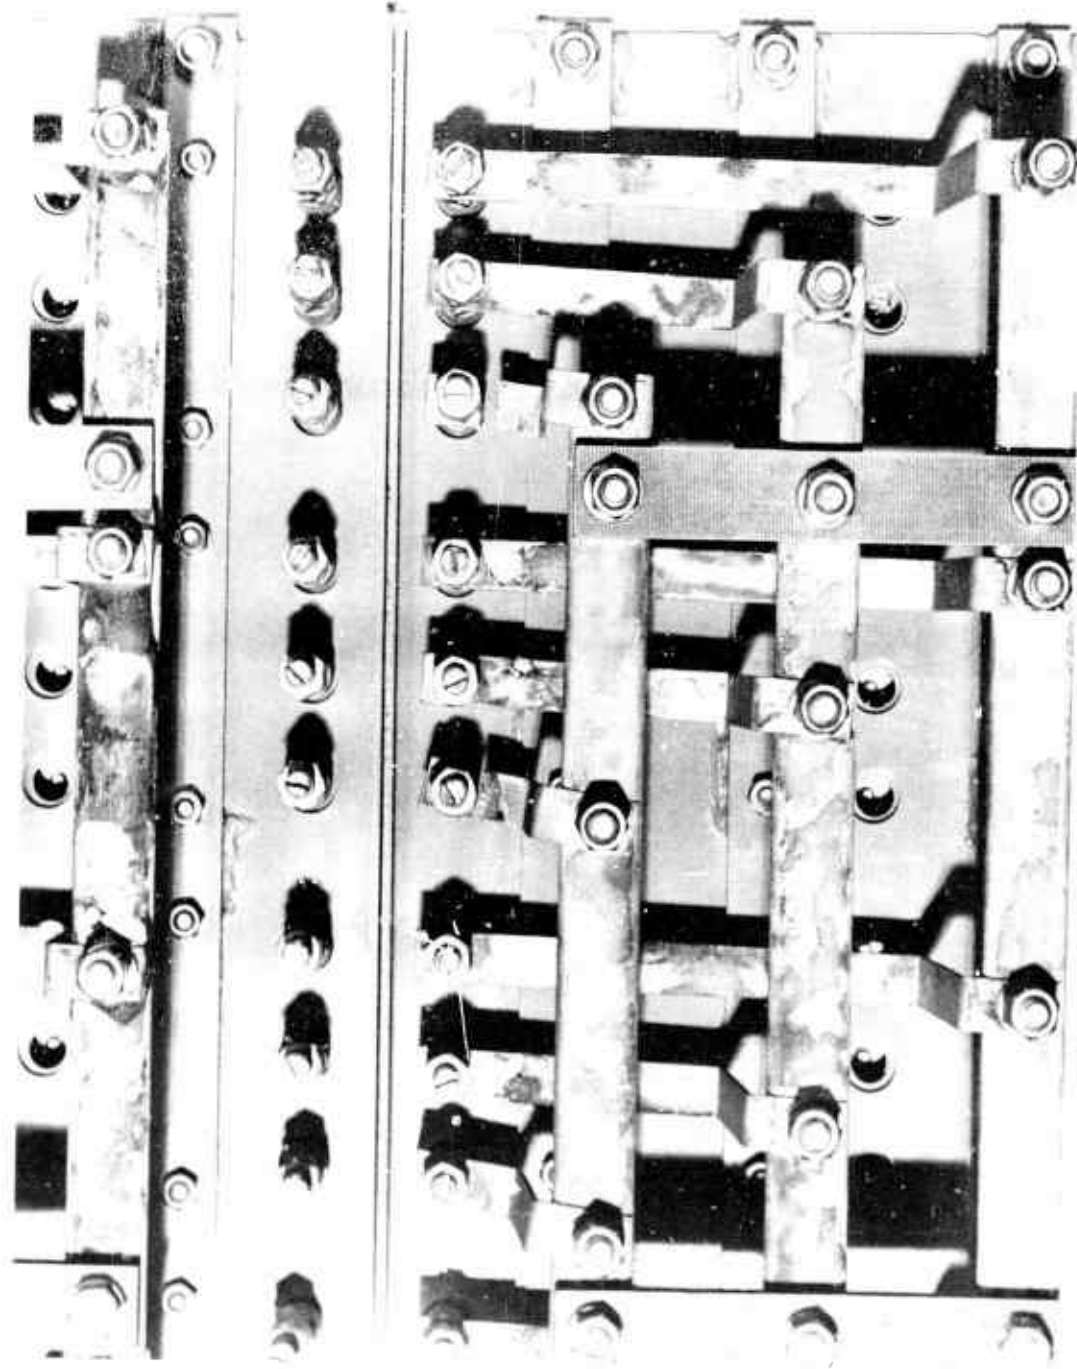
Fig. 20 - Damage from vibration test - middle horizontal bus (LF101). Note broken feeds from bus to breakers.

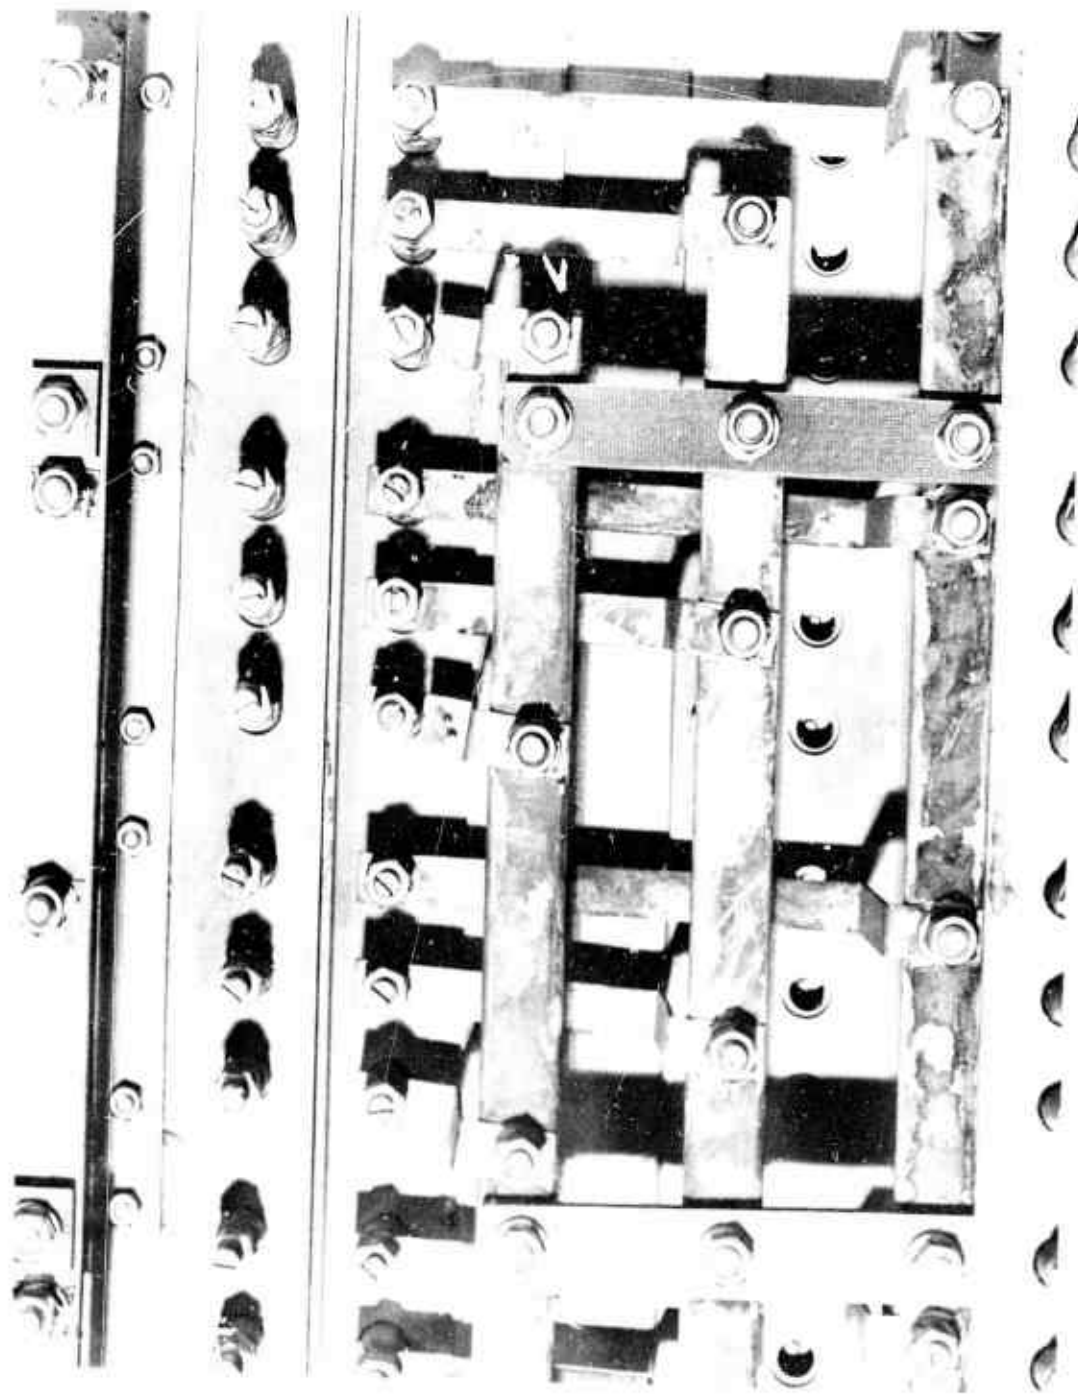
Fig. 21 - Damage from vibration test - lower horizontal bus (LF101). Note broken feeds from bus to breakers.

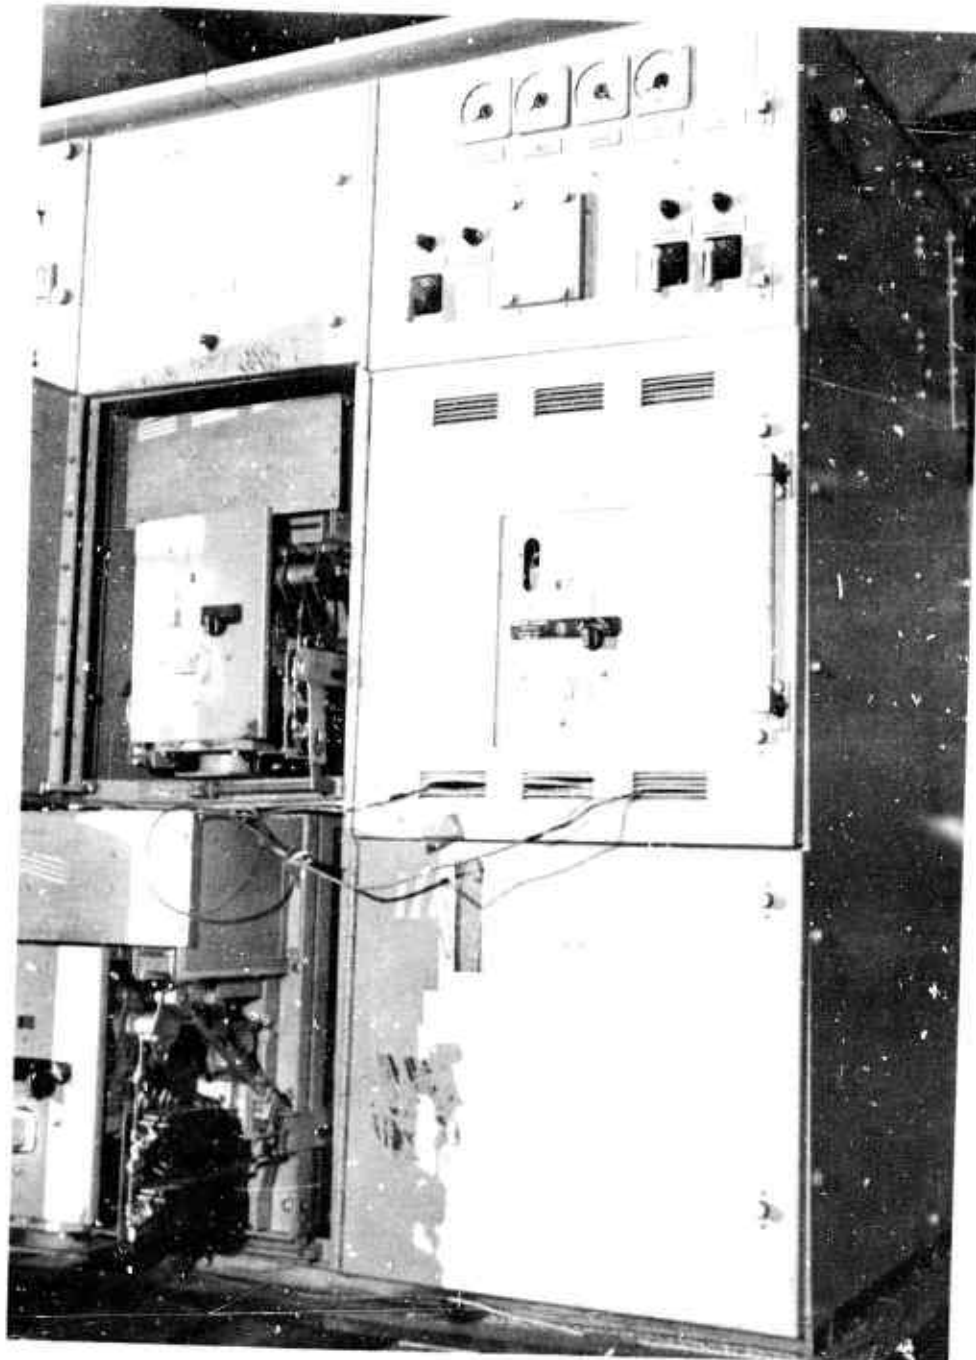
1. All six door-panels tilted downward because of slippage of the hinges, and louvers were torn (Figs. 26, 32 and 33).
2. The door panel of ACB-1600 No. 2 was jammed closed due to damage of the lower lock (Fig. 32).

3. The horizontal frame members below the ACB breakers were bent downward from impact by the breakers (Figs. 26, 27, 28, 30, 32, 33 and 35).
4. The interlock mechanisms of the ACB breakers were damaged, those of ACB 1600 No. 2 and the ACB 2400 having their actuator pins bent and that of ACB 1600 No. 1 being knocked out completely (Figs. 28, 29, 32, 34 and 36).

Fig. 26 - Damage from Vertical Shock. Note tilting of panel doors due to slippage of the hinges on the switchgear frame, and bending of the horizontal frame member below the upper 1600 A breaker. Photographed after Blow 3 (5-1/2 ft. Drop, 3 in 2 panel), but similar damage was noted for the preceding 3-1/4 ft. Drop blows.

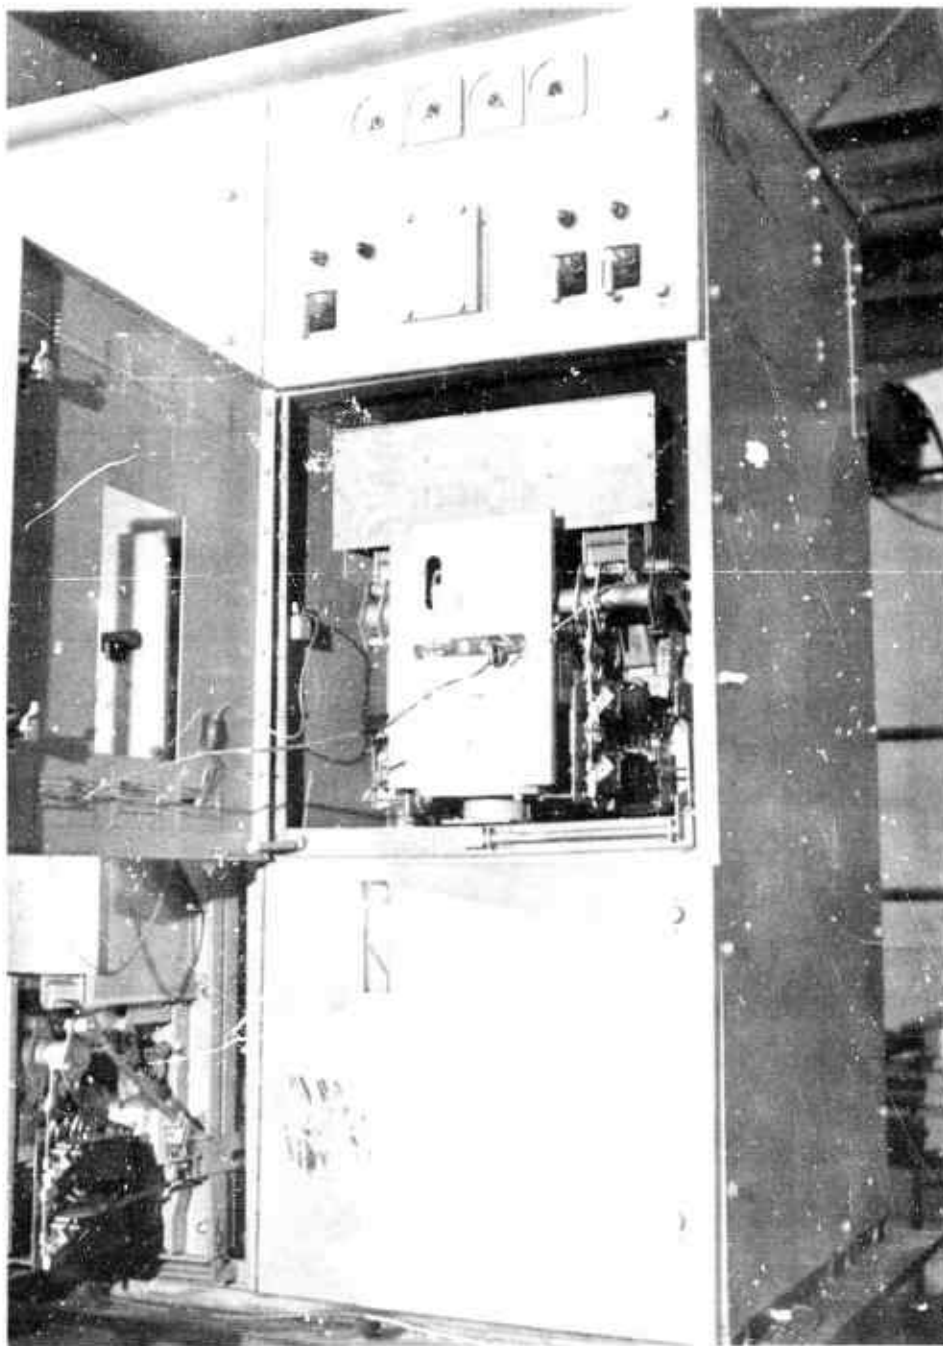
Fig. 27 - Damage from Vertical Shock. Note deformation of horizontal frame member below the 2400 A breaker, and misalignment of panel door hinge. (After Blow 3).

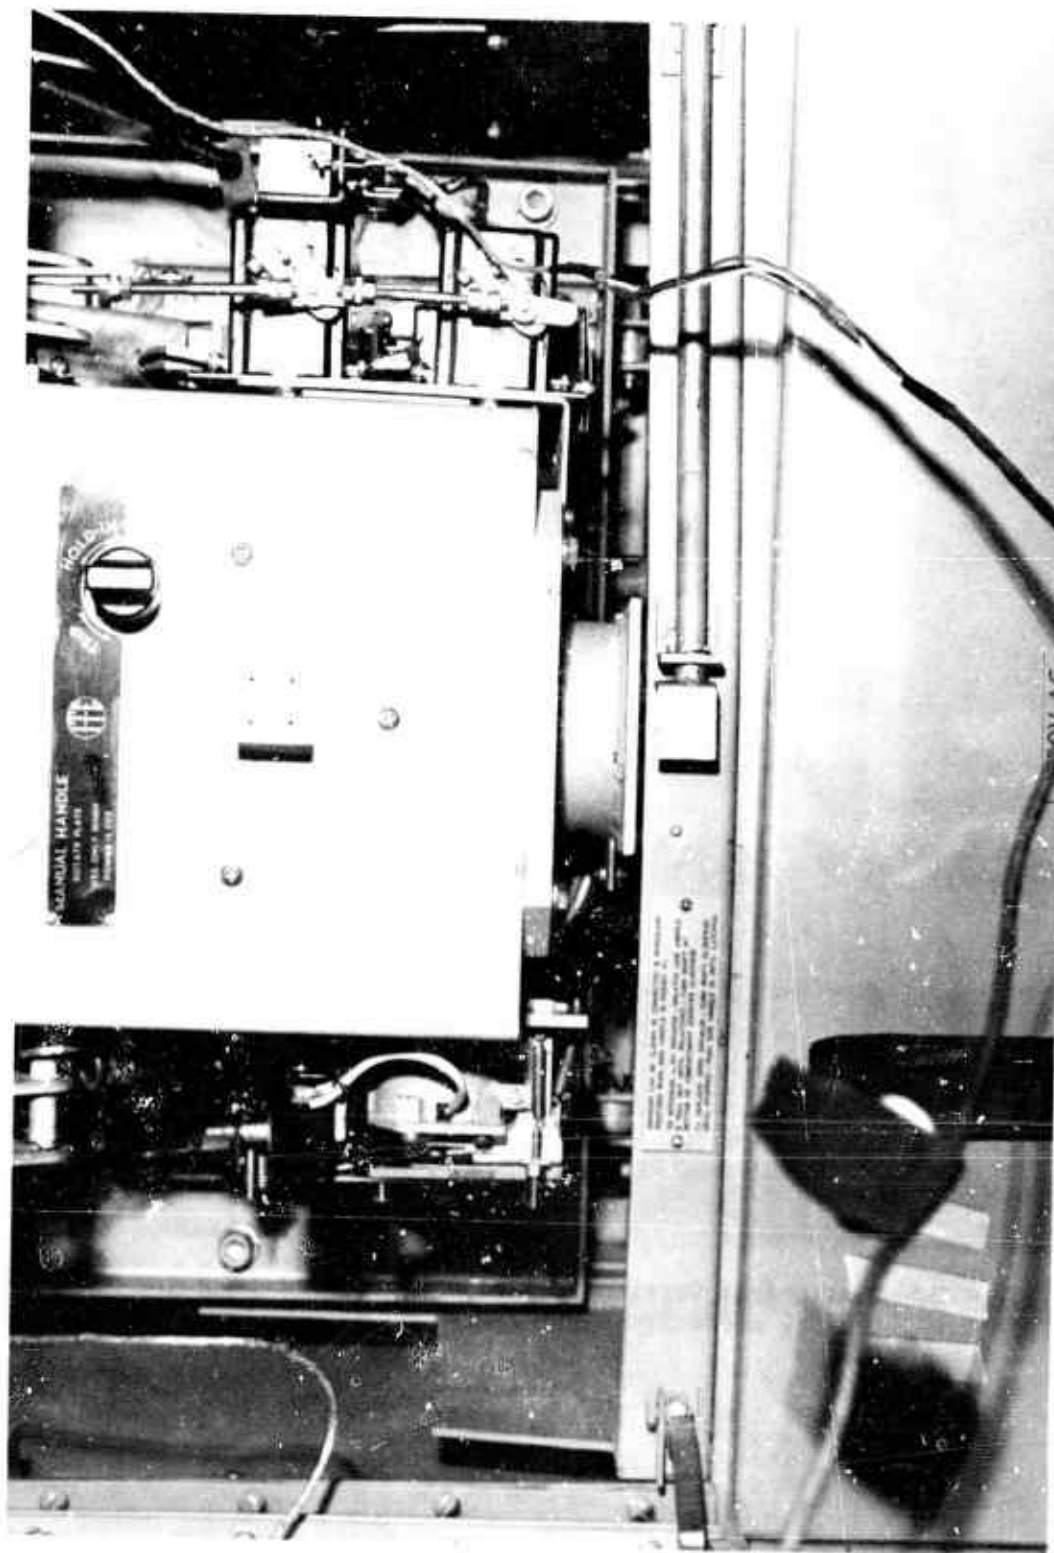
Fig. 28 - Damage from Vertical Shock - 2400 A Breaker Compartment. Note deformation of interlock mechanism (far right), breaker support, horizontal frame member; and slippage of panel-door hinge. (After Blow 3).

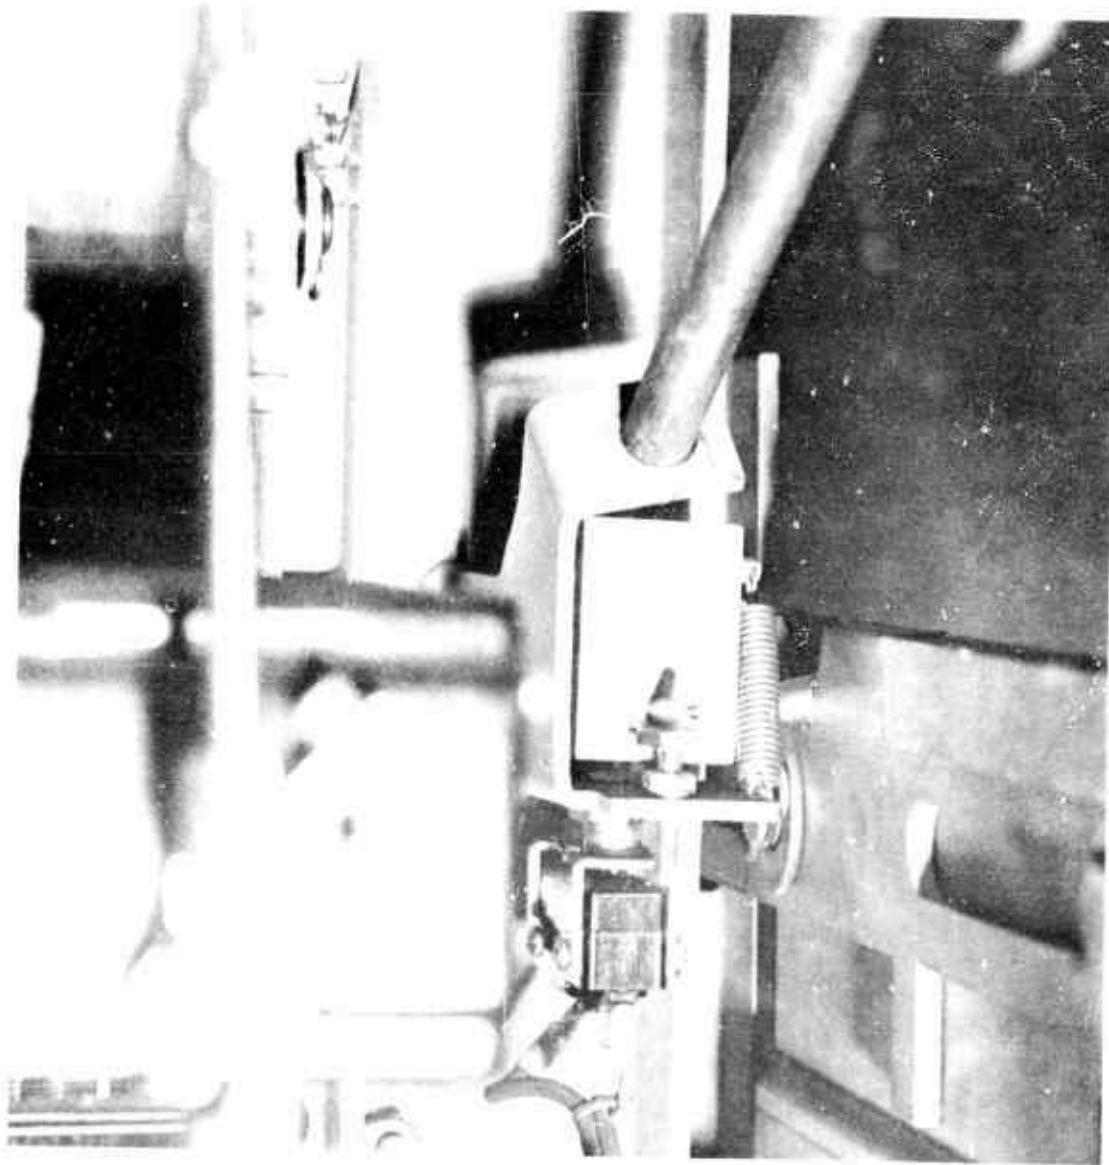
Fig. 29 - Damage from Vertical Shock. Detail of damage to 2400 A breaker interlock mechanism after Blow 3.

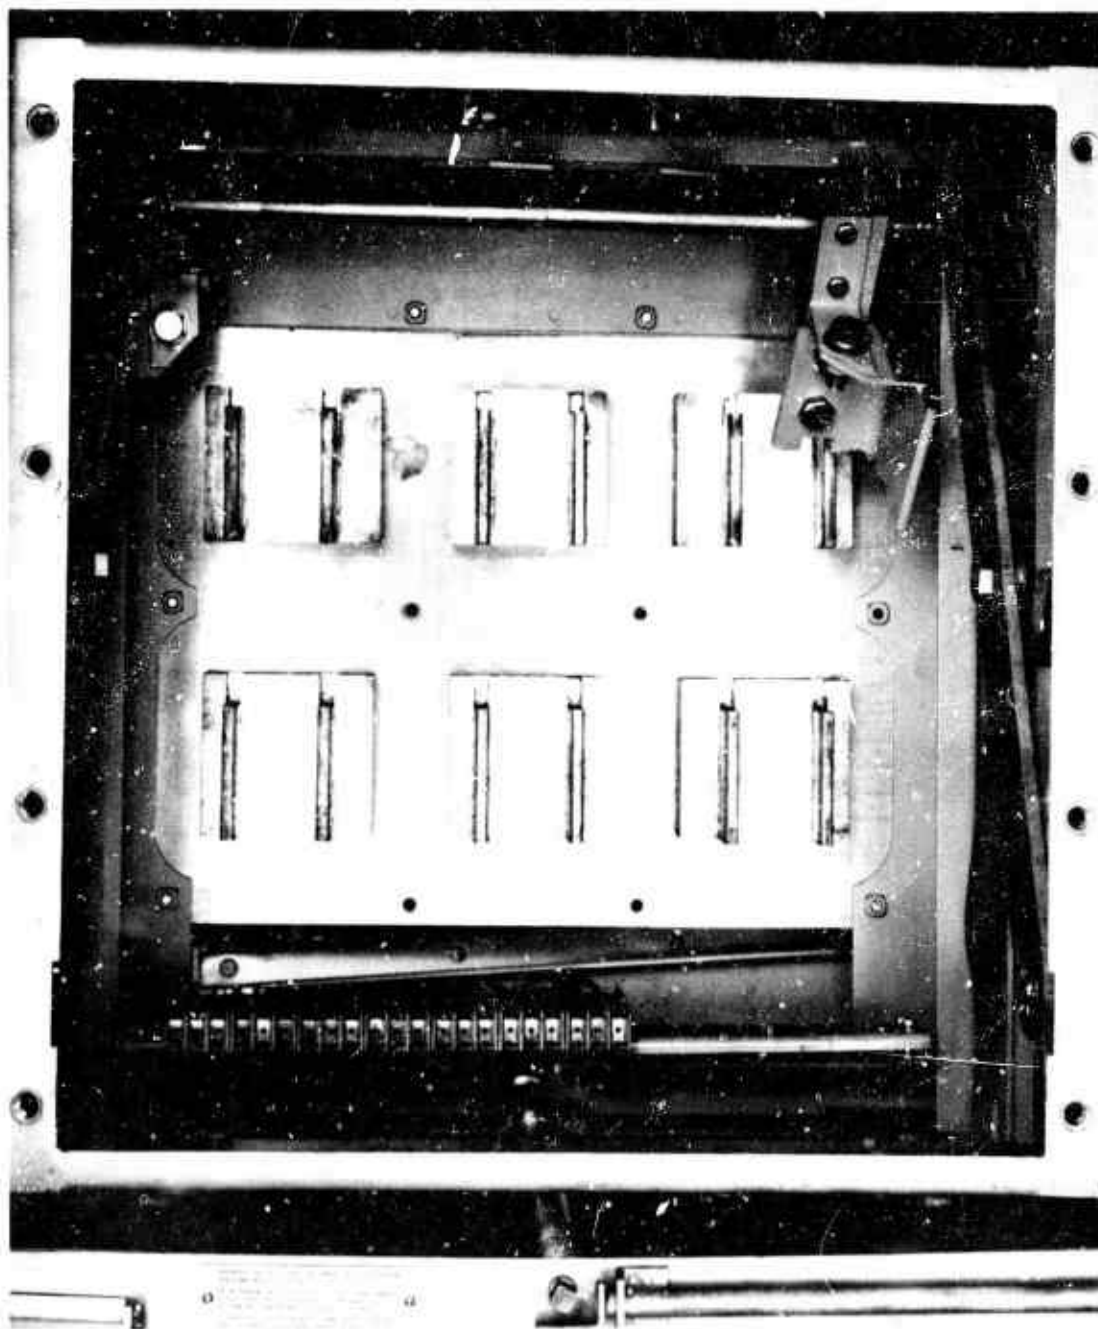
6. One of the brackets holding the frame for the ACB 2400 breaker was broken off, and the upper guide and lock plate was bent. The bolts holding the melamine connector panel sheared, allowing the panel to slip down (Figs. 30, 37, 38, 39 and 40).

Fig. 30 - Damage from Vertical Shock - 2400 A Breaker Compartment. Note deformation of breaker support frame, broken support bracket (upper right). The eight bolts holding the melamine board to the metal frame with captive nuts were sheared off. The four bolts through the holes in the board survived, but have been removed here for repairs. (After Blow 3).

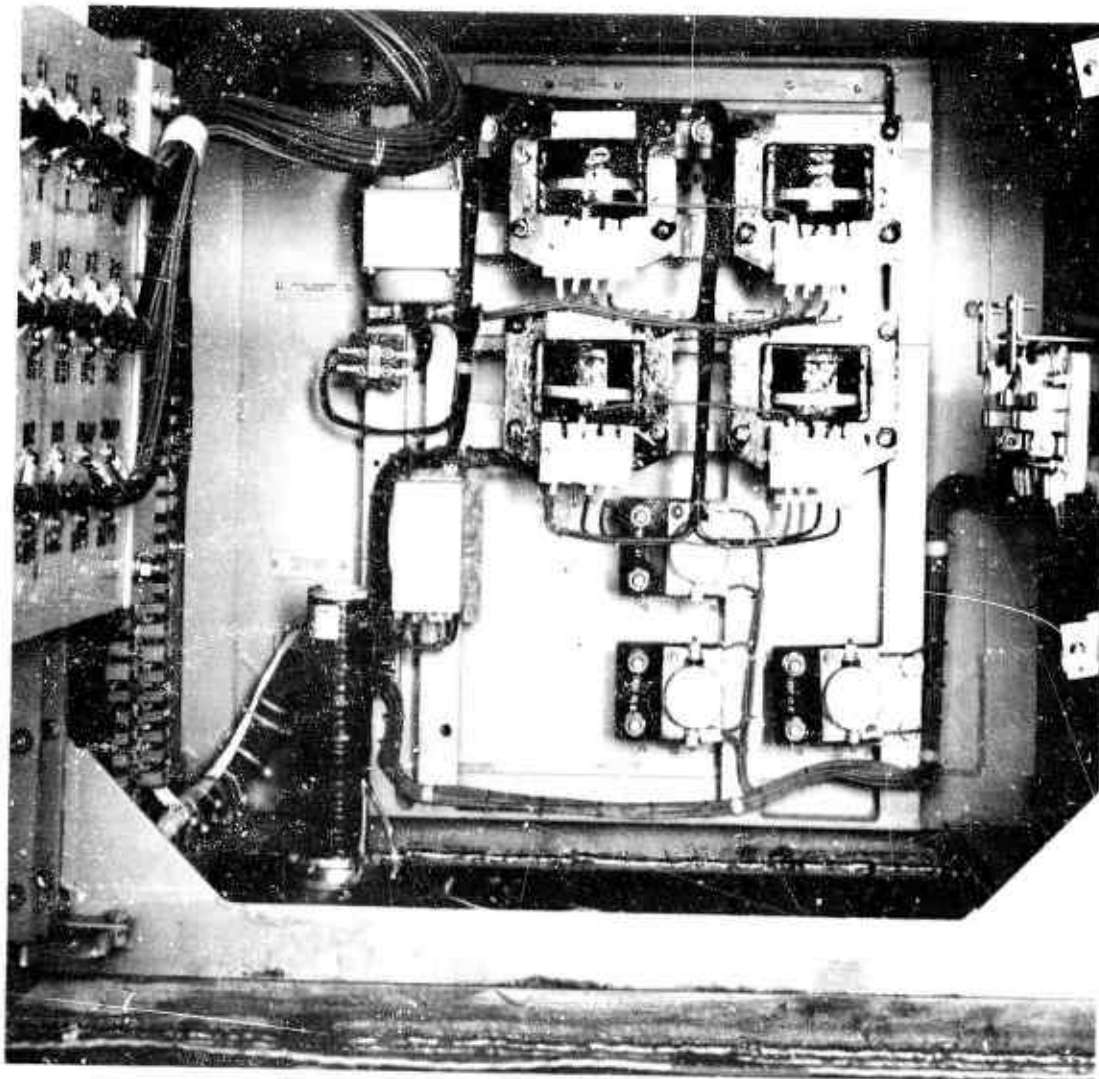
Fig. 31 - Damage from Vertical Shock - Fuse Compartment. Note slippage of fuse board hinge and damage of fuse board and fasteners. The vertical black cylinder at lower left is the velocity meter. (After Blow 3).

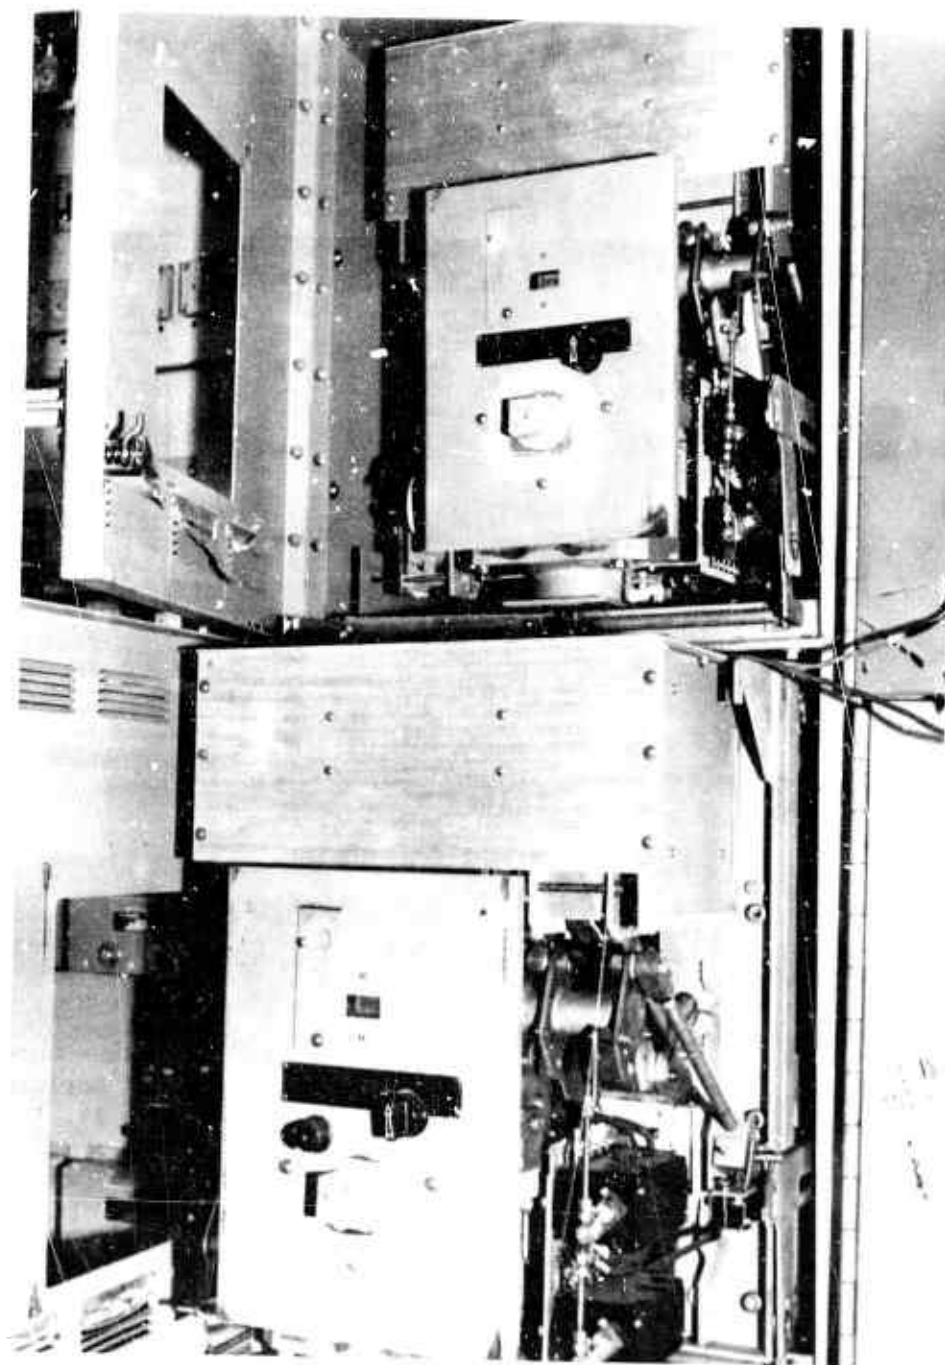
Fig. 32 - Damage from Vertical Shock - 1600 A Breaker Compartments. Note damage to panel door louvers and locks. (After Blow 3).

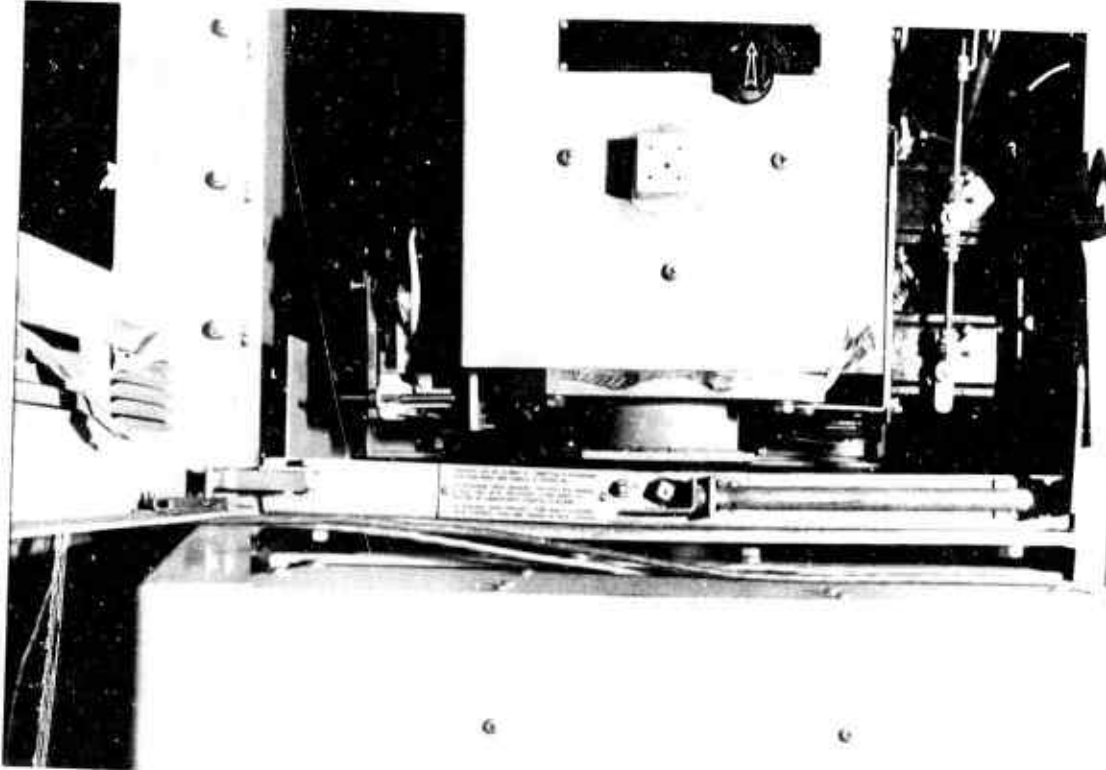
Fig. 33 - Damage from Vertical Shock - upper 1600 A Breaker Compartment. Note deformation of breaker support upper and horizontal frame member, and damage to panel door. (After Blow 3).

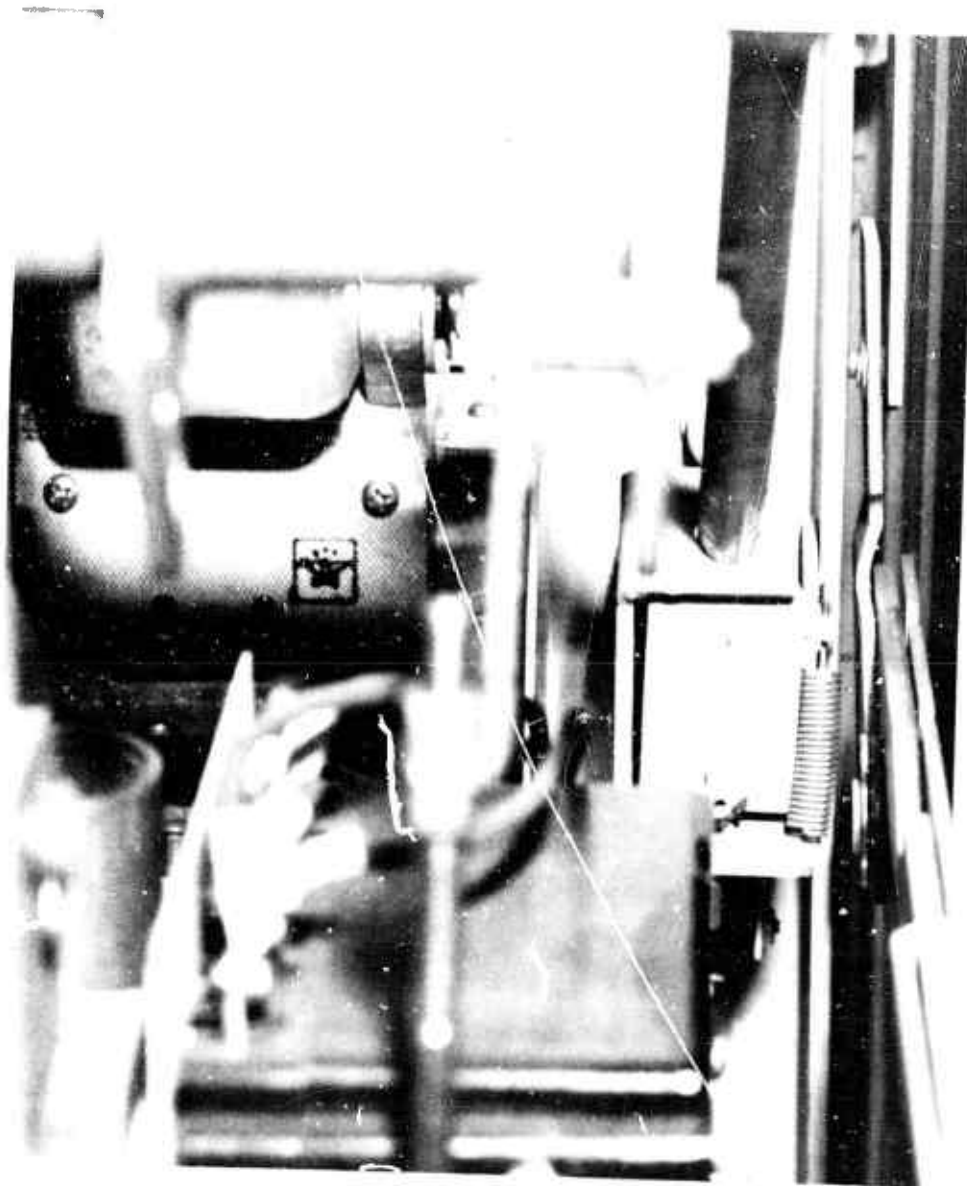
Fig. 34 - Damage from Vertical Shock - upper 1600 A Breaker Compartment. Detail of damage to interlock mechanism. (After blow 3).

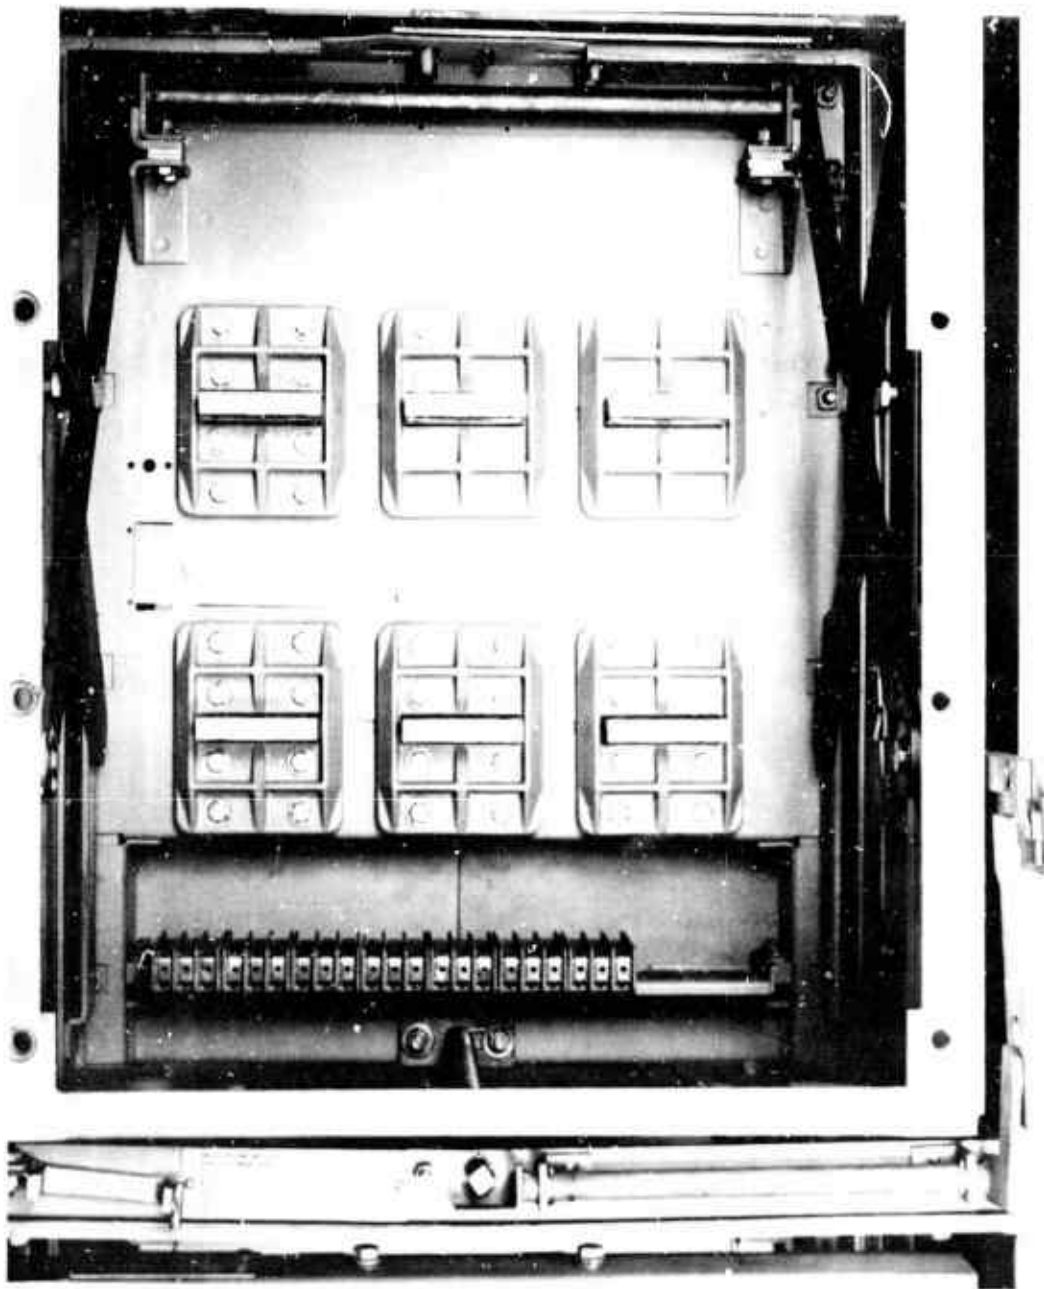
Fig. 35 - Damage from Vertical Shock - upper 1600 A Breaker Compartment. Note deformation of breaker support frame, particularly at top. (After Blow 3).
